Manhole Inspection Summary

Manhole # S07II2014MH

Location Address: **6329 GREEN MEADOW PKWY** Cross Street: **OLD PIMILICO RD**

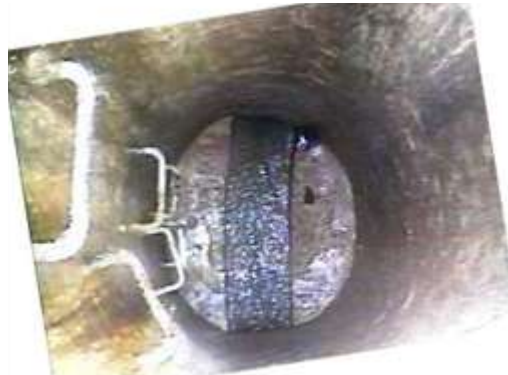
Top View

Bench debris.

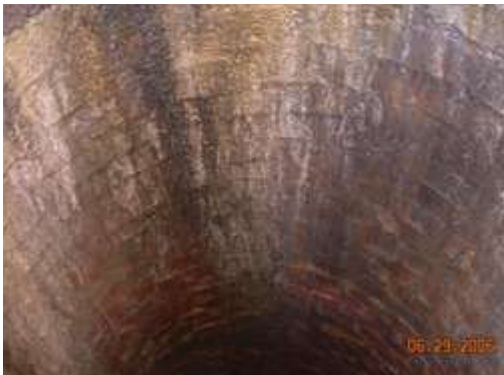
Defect

Adjustment and Corbel infiltration.

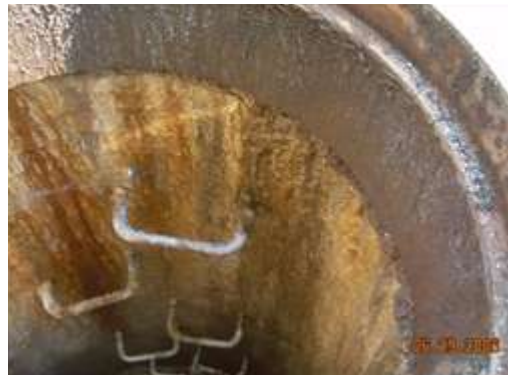
Defect

Frame leaks. Adjustment deterioration and infiltration.

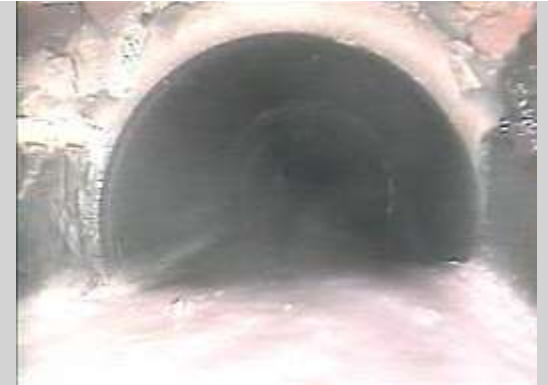
15 in. Circular Gravity Sewer Pipe Out @ 12 O'Clock

Infiltration: **Evidence** Pipe Seal Cond: **Unknown**
